PRESS STATEMENT

Safety Notice

130005 EMEAR

Date:	July 29, 2013
Model Affected:	Z-135/70
Subject:	Secondary Boom Angle Sensor Calibration
Allowable Hours:	60 minutes

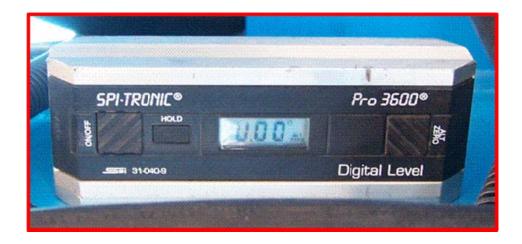
4. Place the digital level on the swing chassis as shown below.

5. Set the digital level read out to zero.

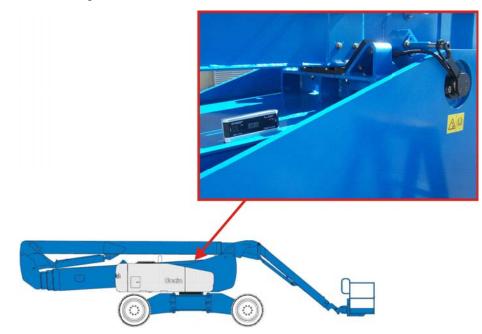
6. Working on the same side of the machine, move the digital level from the swing chassis to the top of the secondary boom closest to the pivot end as shown below. Do not change the orientation of the digital level.

- 8. Record the value displayed on the digital level in the attached "Completion Form".
 - If the value is greater than or equal to (≥) 75.5 °, the machine is safe to use and can be returned to service. Finish filling out the "Completion Form" and return to Genie. No further action is required.
 - ⊗ If the value is less than (<) 75.5 °, the machine must remain out of service. The secondary boom angle sensor will need to be calibrated. Continue on to step 9.</p>

Calibrate the secondary angle sensor of the machine per the instructions in the machine's service manual (section 4-9). Record the desired digital level reading, greater than or equal to (≥) 75.5 °, after calibration in the attached Completion Form.
