# PROTECTA SHOCK ABSORBING TWIN-LEG LANYARDS

# **REVISED RECALL NOTICE**

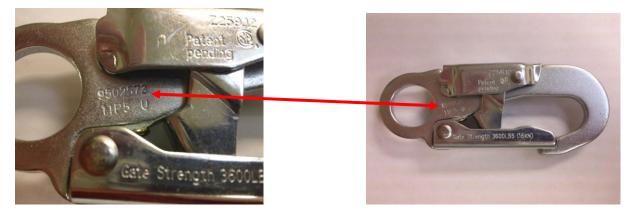
The snaphook # 9502573 used in affected twin-leg lanyards is identified as follows:

Distributors that have purchased the affected products will be notified of this recall and will in turn notify their customers. Upon notification, if you have twin leg Protecta lanyards with snaphook # 9502573 as identified in above photographs, you should immediately take the lanyard(s) out of service and contact your Capital Safety Distributor or Capital Safety Customer Service department at 800-328-6146 (prompt #1) to obtain a "QA" number for the return of the lanyard(s) and to be provided with a new Protecta lanyard at Capital Safety's expense. The free lanyard applies only if the returned lanyard is in proper working condition as determined by Capital Safety; if not, charges may apply. Alternatively, you may request a different style Protecta lanyard or a DBI-SALA brand lanyard, however charges may apply depending on your selection.

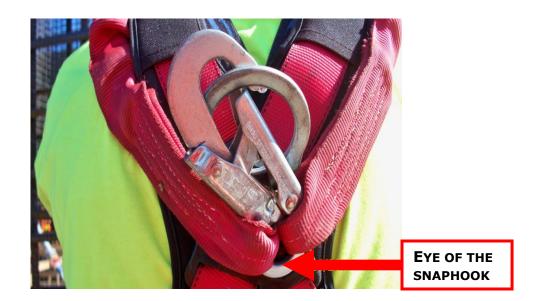
In a particular configuration when the twin lanyard legs are pulled upwards simultaneously and the snaphook gets compressed against the d-ring, the combination of forces acting on both the locking mechanism and the gate opening of the snaphook may cause the snaphook to disconnect from the d-ring. (See photo below)

The identified reason for the inadvertent disconnection is the combination of a particular style locking snaphook together with twin elastic lanyard legs attached directly to the eye of the snaphook. Although there have been no reported falls or injuries associated with the use of this configuration lanyard, CS is committed to the safety of every worker at height using our products and we are determined to resolve any potential for inadvertent disconnection to occur for the reason described above.

Capital Safety has determined that the appropriate solution to the identified issue is a combination of (a) an alternate snaphook and (b) a single lanyard connection to the eye of the snaphook. Accordingly, we have engineered a new version of the affected lanyards to take into account what we have learned about the combination of components on the Protecta shock-absorbing lanyards.
