ROLLNLOCK

REQUEST FOR INSPECTION

Climbing Technology has voluntarily issued a request for inspection of the ROLLNLOCK pulley/rope clamp (Ref. No. 2D652) by the user

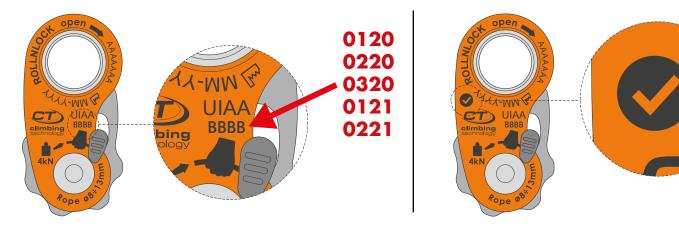
Attention! In order to distinguish, with the same batch, a functioning product from a defective one, we have inserted a symbol on the marking. Whoever is in possession of a product marked with this symbol will not have to carry out any inspection.
