RECALL NOTICE FOR OMNI 1.1 PULLEYS & VARIANTS MADE FEBRUARY 2020 THROUGH OCTOBER 2022

Recall Notice for Omni 1.1" Pulley Variants, 20050xxx through 22304xxx: Stop Use, Remove from Service & Return to Rock Exotica

Inspection Notice for Omni Pulleys from 2018 to Current: Inspect Before Next Use

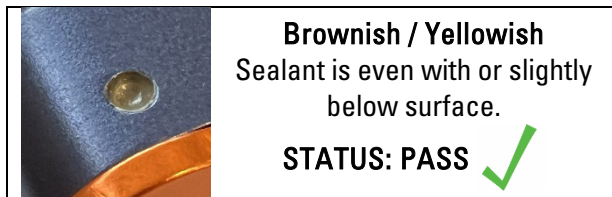
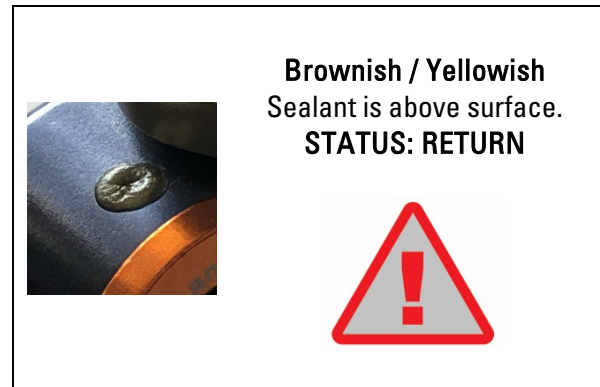
Inspection Evaluation (from 2018 to current)

The inspection criteria below apply to Omni Pulleys manufactured from about 2018 to the current date. The serial number corresponding to this period begins at **18001xxx**.

- Identify the location of the set screw(s) on your Omni Pulley.
- Compare the images in the inspection criteria to your pulley.
- Follow the inspection instructions to determine if you are required to return your pulleys for additional inspection by Rock Exotica and repair if necessary.
